**Bankhead Liaison Panel Timber and Thinning Team**

**Check List for Timber Thinning Site Evaluations**

Inspection Date: 5/22/2007 Time: 9:30 Age: 30  
Location: Compartment: 148 Stand: 10 Acres: 32 DFC: LLW  
Coordinates: Latitude: \_\_\_\_\_ Longitude: \_\_\_\_\_  
Original Treatment Date: 11/04 Original Treatment: thin  
Additional Treatment Date: 2/05 Additional Treatment: mid story treatment  
Additional Treatment Date: 4/15/05 Additional Treatment: burn  
Additional Treatment Date: 5/007 Additional Treatment: burn

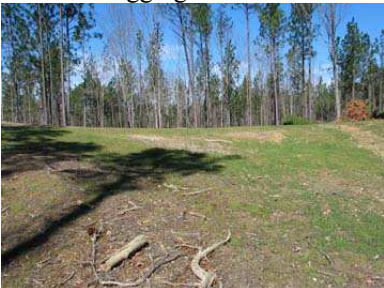
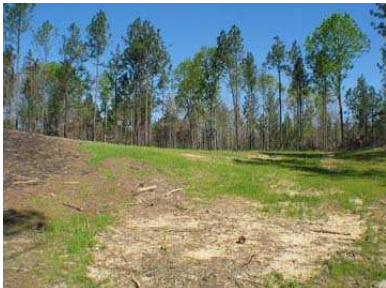
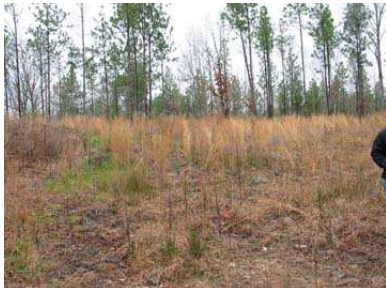
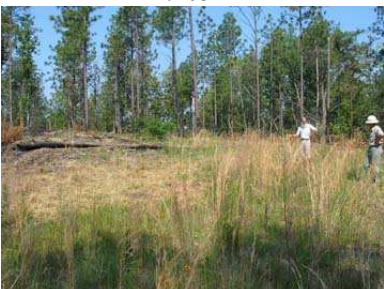
5-22-07					
2.	Logging deck	148-2-2	34-5-52	87-23-34	330°

II e. Many items on the checklist could be marked for the discussion on the logging deck. The deck was disked and reseeded after the original timber sale. Since it was partially on a slope there were some problems with minor erosion. Due to poor thin soil on the deck, the planted grass did not completely take on the surface. It was felt that if topsoil moved from the deck were pulled back over the deck before planting, the seed would have a better chance of germinating. \_\_\_\_\_

Recommended Follow-up Actions and Schedules: Evaluate the deck discussion and determine if it would be worthwhile to move topsoil back over future decks before re-seeding. Evaluation of drought and fire impacts should be considered later in season
