Response to Gilbert Cosio's comments on the article "Evolution of arability and land use in the Sacramento-San Joaquin Delta"

Appendix – Aerial Photographic Images for Habitat Areas

Comparison of 1980s Color Infrared and subsequent photos

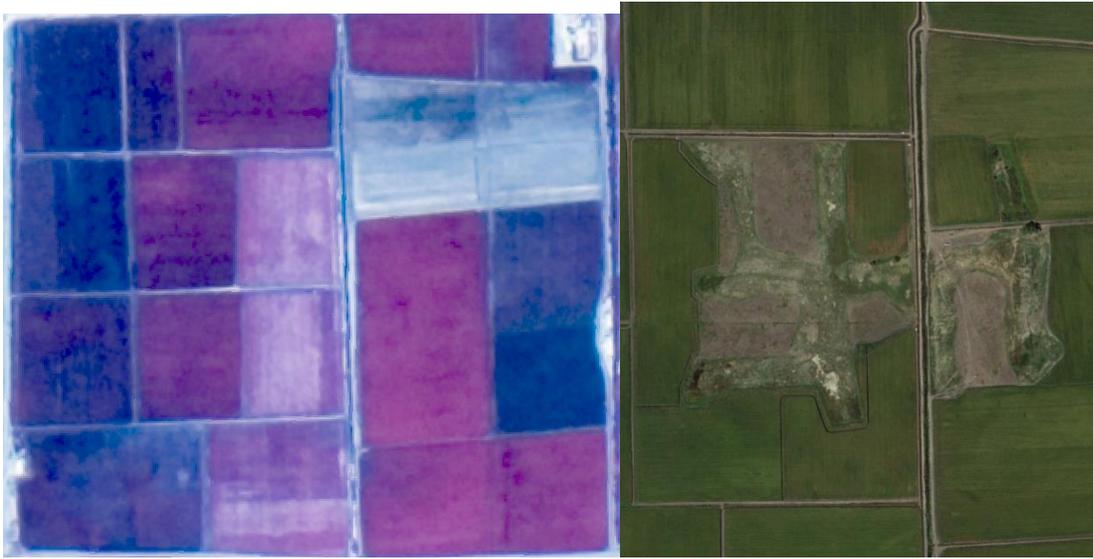
Figure A1. Bishop Tract, 1984 CIR (left), 2012 (right). Light colored and bluish red areas became wetland area.

Island	Area in hectares (acres)	Time series summary	Approximate present-day soil organic matter percentage	Habitat present in the 1980s?	Distance to channel or slough in meters (feet)	Elevation in meters (feet)
Bishop Tract	20.5 (50.6)	September 1984 CIR (color-infrared) photo shows blue areas indicating wet conditions. Constructed wetlands apparent in 1993 overlay the 1984 wet areas. Wetlands were surrounded by fallow areas in 1998 and 2002. Wetlands were surrounded by farmed areas in 2008 and 2012.	6%	No	420 (1,338)	-1.31 (-4.30)
Brack Tract	190 (470)	July 1987 CIR photo shows entire area in agriculture, and evidence of wet conditions (dark blue) and plant stress (magenta). 1993 photo indicates similar conditions. 2002 photo shows presence of wetland in western fields in the location of wet conditions apparent in the 1987 photo. Fallow and irregularities in areas in the eastern area near the slough are apparent where wet conditions were observed in the 1987 CIR photo. Wetlands present eastern area 2006–2012.	45%	No	Immediately adjacent	-2.82 (-9.25)

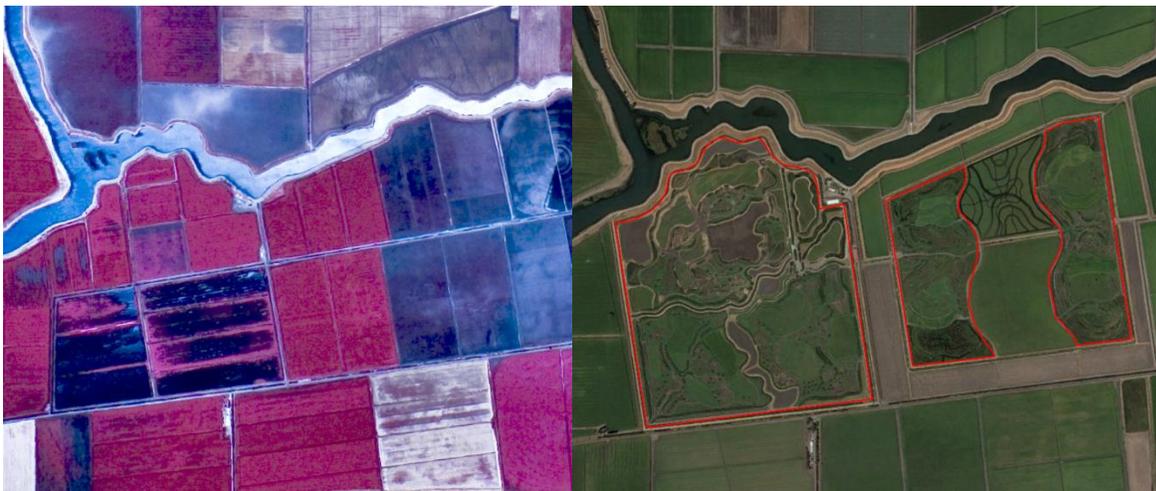
Figure A2. Brack Tract, 1987 CIR (left), 2012 (right). Dark blue, bluish red, magenta (wetter) areas in 1987 were wetland in 2012.

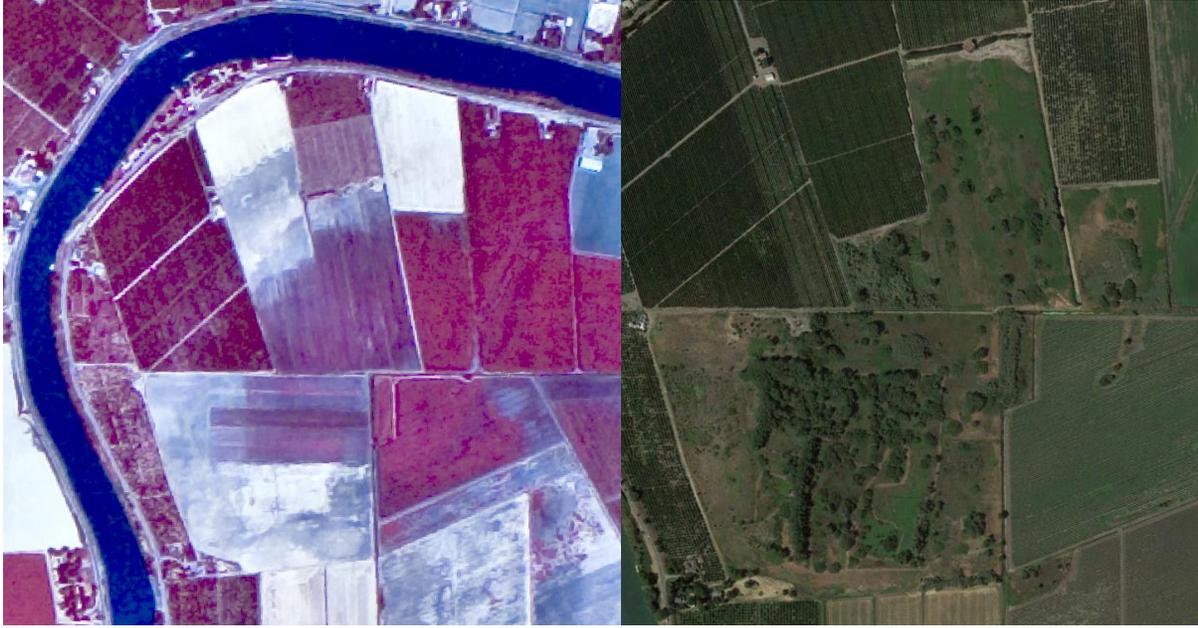
Figure A3. Branran-Andrus Island, 1987 CIR (left), 2012 (right). White, light blue, bluish red areas (wet and non-cultivated areas) in 1987 were habitat in 2012.

Brannan-Andrus	45.7 (113)	1987 CIR photo shows that the area is delineated for farming with variable-density vegetation and wet conditions. The remainder of the area is bare soil, with dark spotting indicating zones of high soil moisture. 1993 photo indicates similar conditions. Photos from 2002 to 2012 show transition to wetlands.	11%	No	118 (1,043)	-0.44 (-1.44)
Empire Tract	45.6 (113)	September 1987 CIR image and 1993 photo show that the area delineated as habitat in Mr. Cosio's letter was farmed.	45%	No	Immediately adjacent	-3.95 (-12.96)

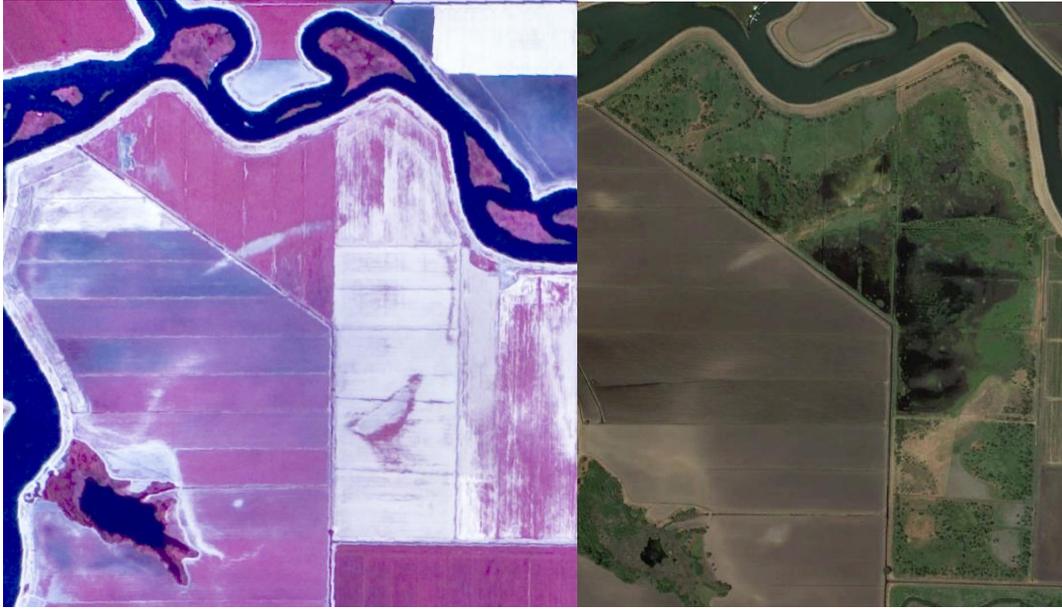
Figure A4. Empire Tract, 1987 CIR (left), 2012 (right). White (fallow) areas in 1987 were wetland in 2012.

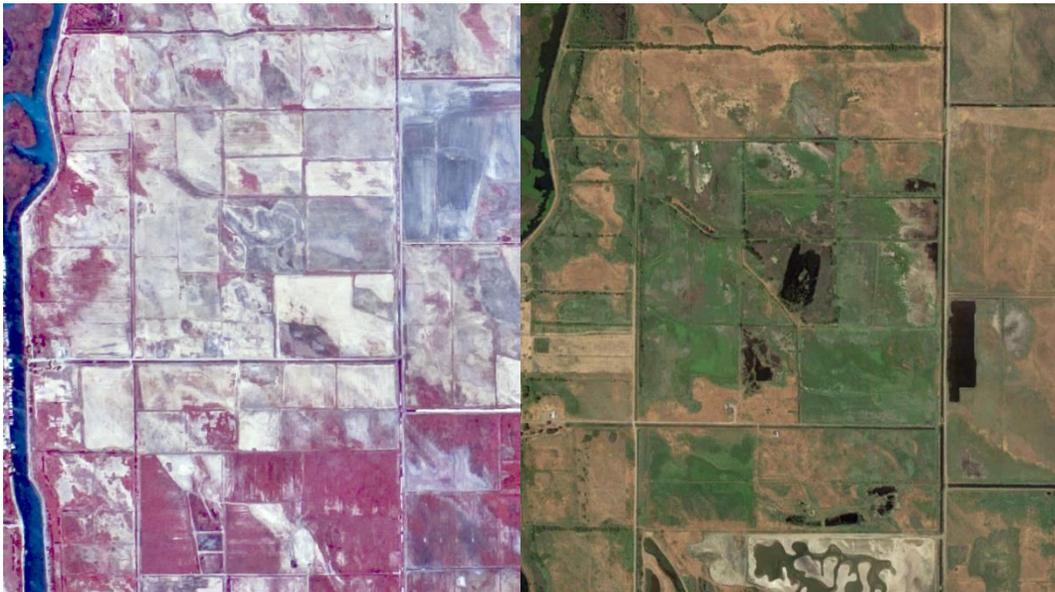
Figure A5. Holland Tract, 1987 CIR (left), 2012 (right). White and bluish white areas in 1987 were wetland in 2012.

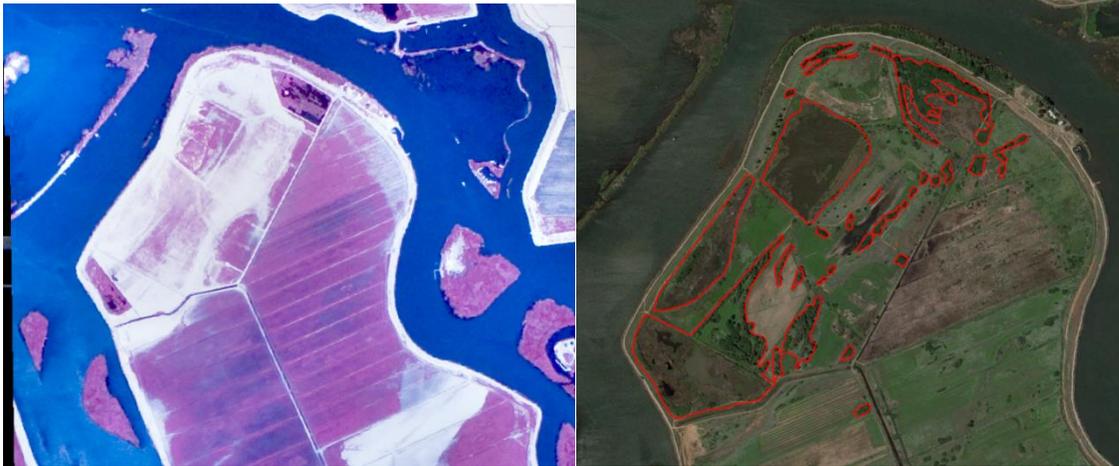
Figure A6. Medford Island (north), 1987 CIR (left), 2012 (right). White areas in 1987 were wetland in 2012.

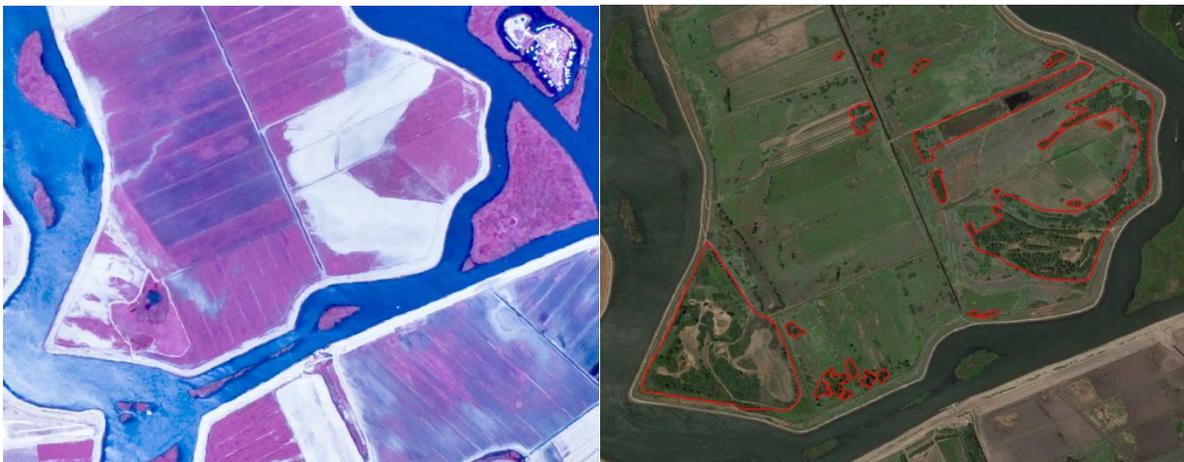
Figure A7. Medford Island (south), 1987 CIR (left), 2012 (right). White areas in 1987 were wetland in 2012.

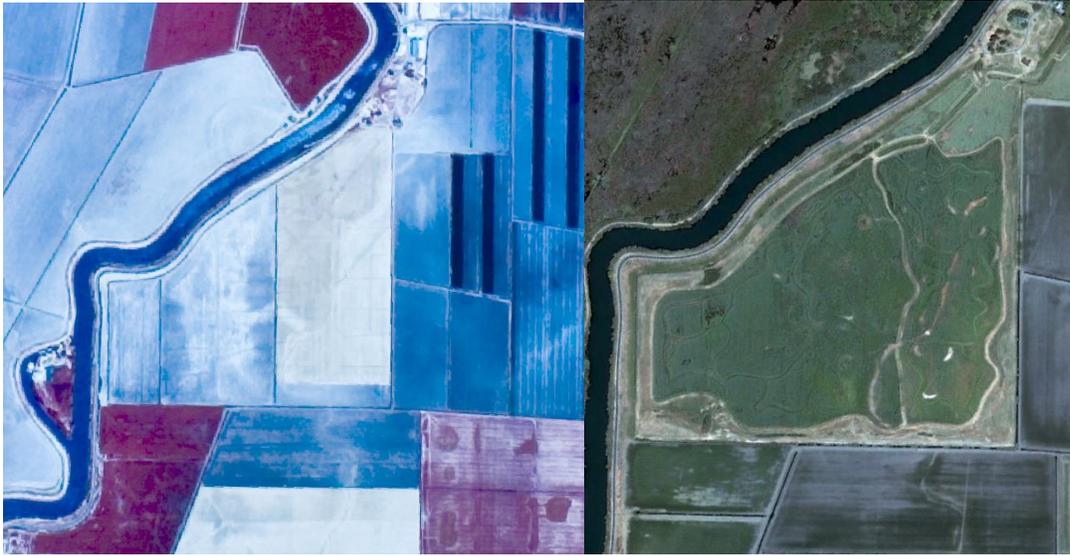
Figure A8. Ryer Island, 1987 CIR (left), 2012 (right). Bluish-white areas in 1984 were wetland in 2012.

Ryer Island	41.2 (102)	July 1987 CIR photo shows blue and white colors associated with bare soil and moist conditions, though field patterns suggests area had been farmed recently. 1993 and 2002 photos show apparent farming under marginal conditions. Land use is unclear in 2005, but marginal conditions have progressed since 2002. Constructed habitat appeared in 2008 and 2012.	0%	No	Immediately adjacent	-0.93 (-3.05)
Sherman Island Mayberry Farms Wetland	128 (317)	July 1987 CIR photo shows that entire area was farmed. Blue and magenta colors indicate vegetated and wet conditions. In 1993, 2002 and 2005 a mixture of wetland and pasture areas can be seen. 2006, 2008, 2010 and 2012 show a progression from wet areas to constructed wetlands in 2010	17.5%	Partially	Immediately adjacent	-3.94 (-12.92)

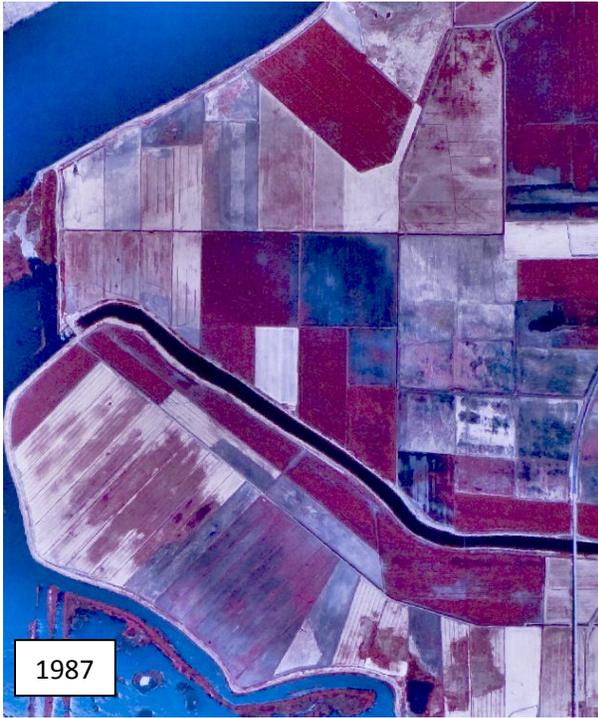
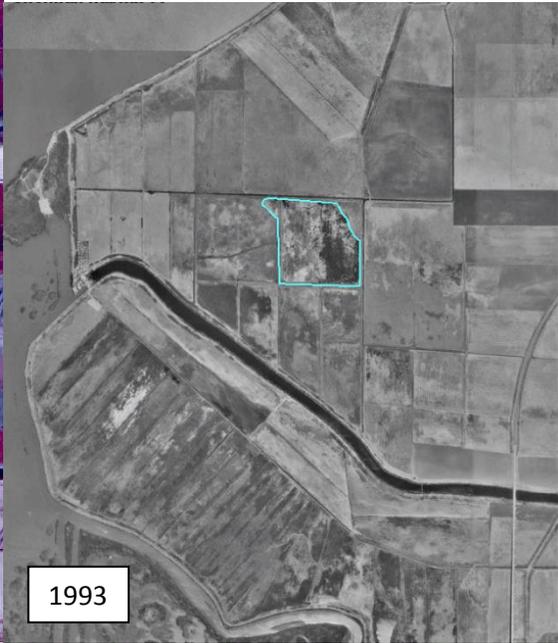
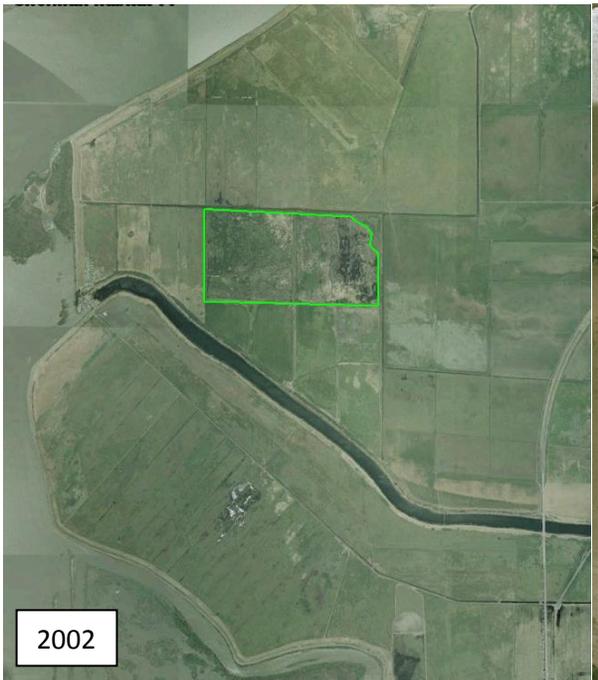
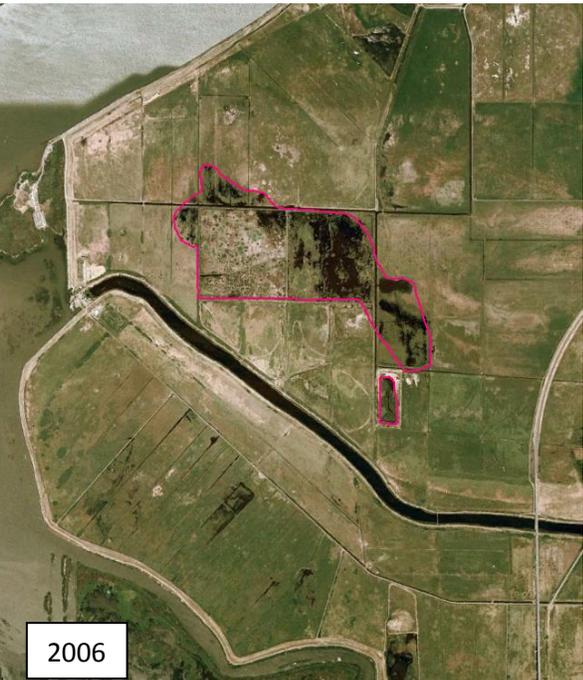
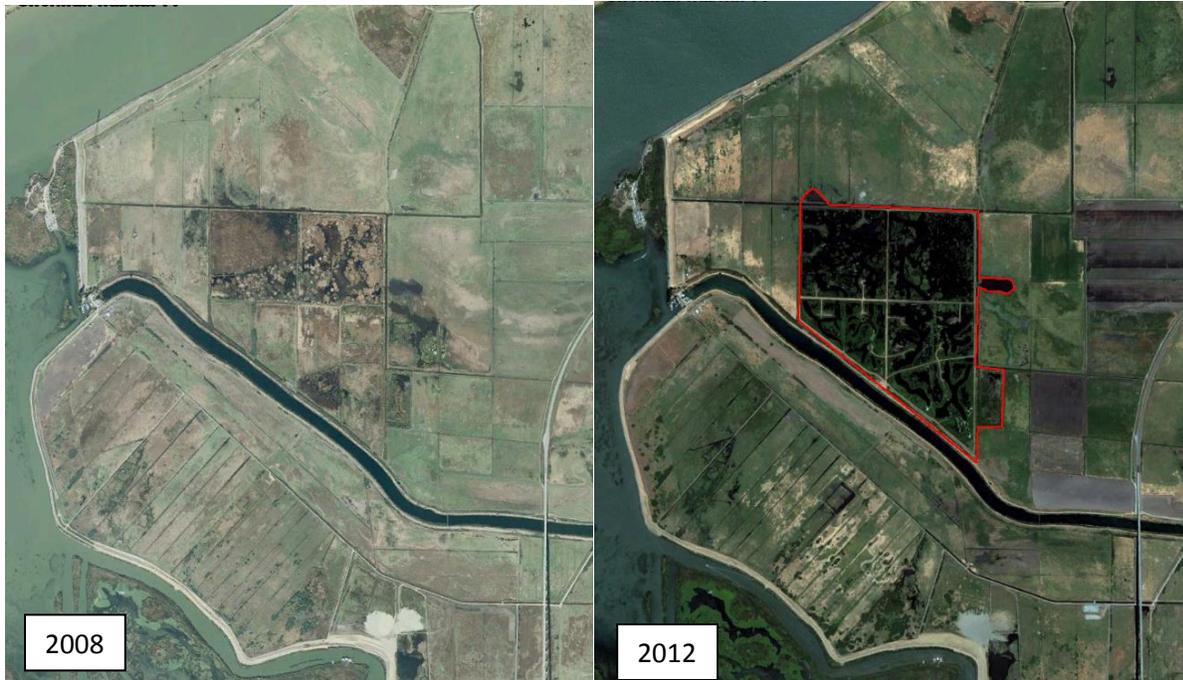
Figure A9. Sherman Island, 1987 to 2012. Photos show a progression from wet farmed areas to wetlands in 2012.

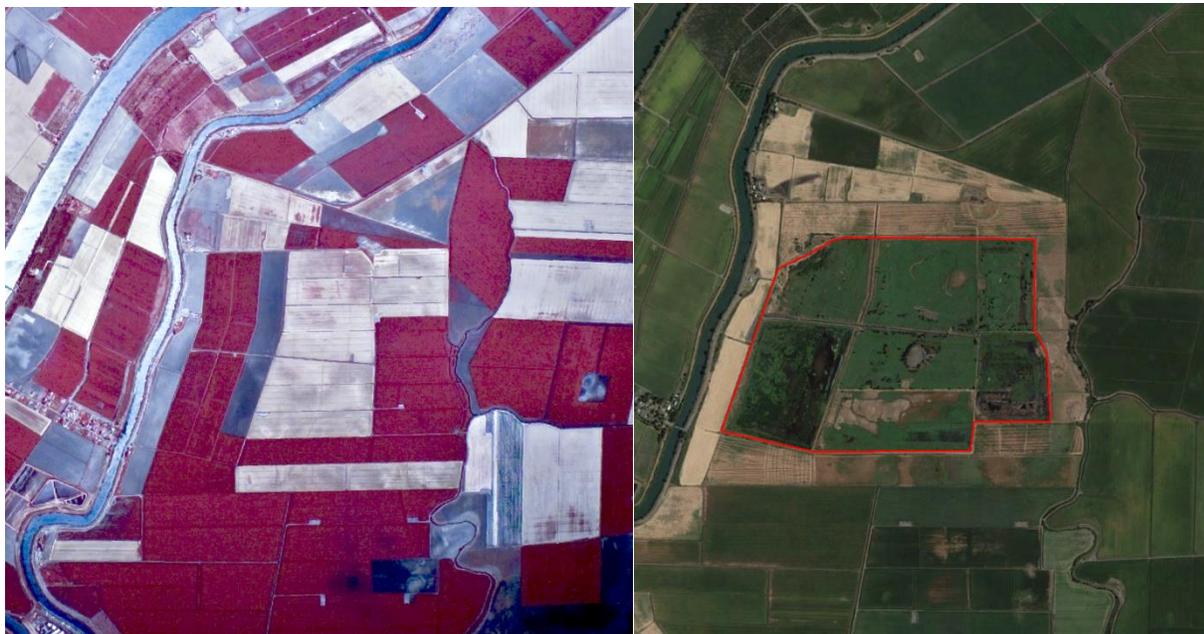
Figure A10. Tyler Island, 1987 CIR (left), 2012 (right). White area in center of 1987 photo became part of wetland by 2012.

Island	Area in hectares (acres)	Time series summary	Approximate present-day soil organic matter percentage	Habitat present in the 1980s?	Distance to channel or slough in meters (feet)	Elevation in meters (feet)
		and 2012.				
Tyler Island	197 (486)	July 1987 CIR photo shows about half of the area being actively cultivated with bright red (healthy) vegetation, with the other half as bare soil or fallow and of varying moisture. Blue areas indicate high moisture. Field patterns suggest that the bare fields were cropped recently. 1993 photo indicates areas of marginal farming. 2002 photo indicates wet conditions and evidence of agricultural use. 2006–2012 photos indicate progressing wetness and presence of wetland.	17.5%	No	Immediately adjacent	-3.53 (-11.58)
Wright-Elmwood Tract	18.8 (46.4)	September 1984 CIR photo indicate the area was farmed. Blue coloring indicates wetness. Constructed wetland habitat appears in 1993, 2002, 2008, and 2012.	40%	No	Immediately adjacent	-1.28 (-4.20)

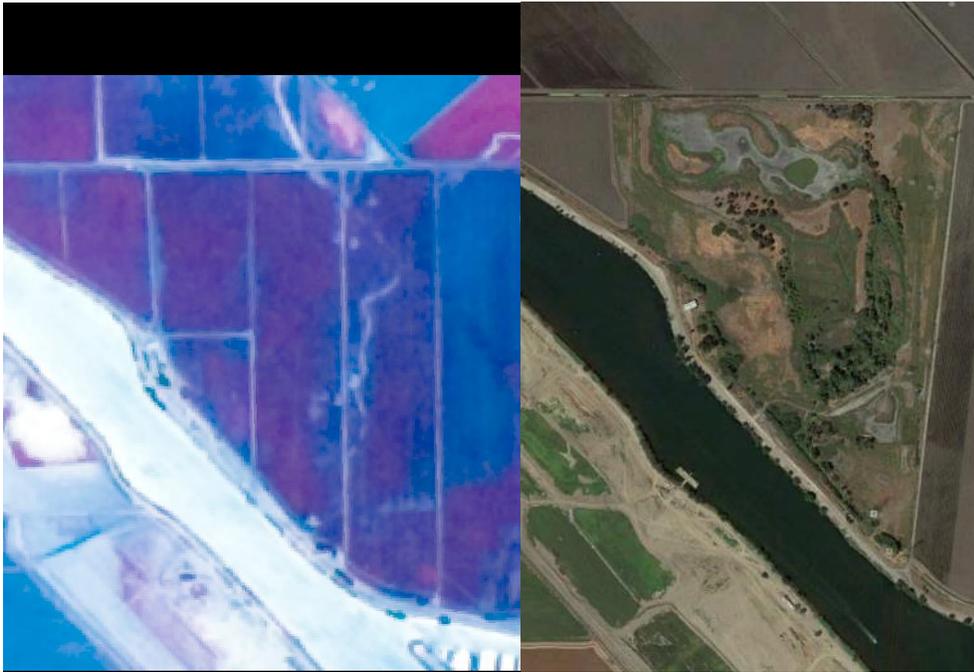
Figure A11. Wright Elmwood Tract, 1984 CIR (left), 2012 (right). Blue and reddish blue areas were wetland in 2012.
