# Floodplains, History, Current Condition, Vision for Future

Brian Cluer, and Charleen Gavette NOAA-NMFS West Coast Region

35<sup>th</sup> Annual Salmonid Restoration Conference March 29-April 1, 2017 in Davis, CA Restoring Watersheds and Rebuilding Salmon Runs

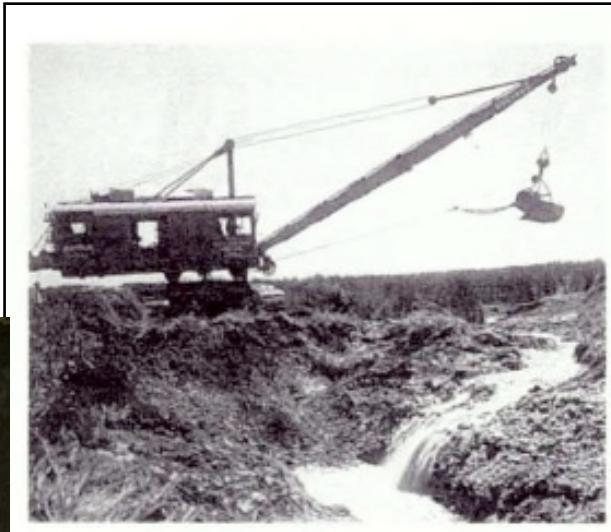
Oil-powered dredge digging a 30-foot-wide ditch to drain wetlands near Carroll, Iowa. (Photograph courtesy of National Archives, 8–D–2214–2570.)

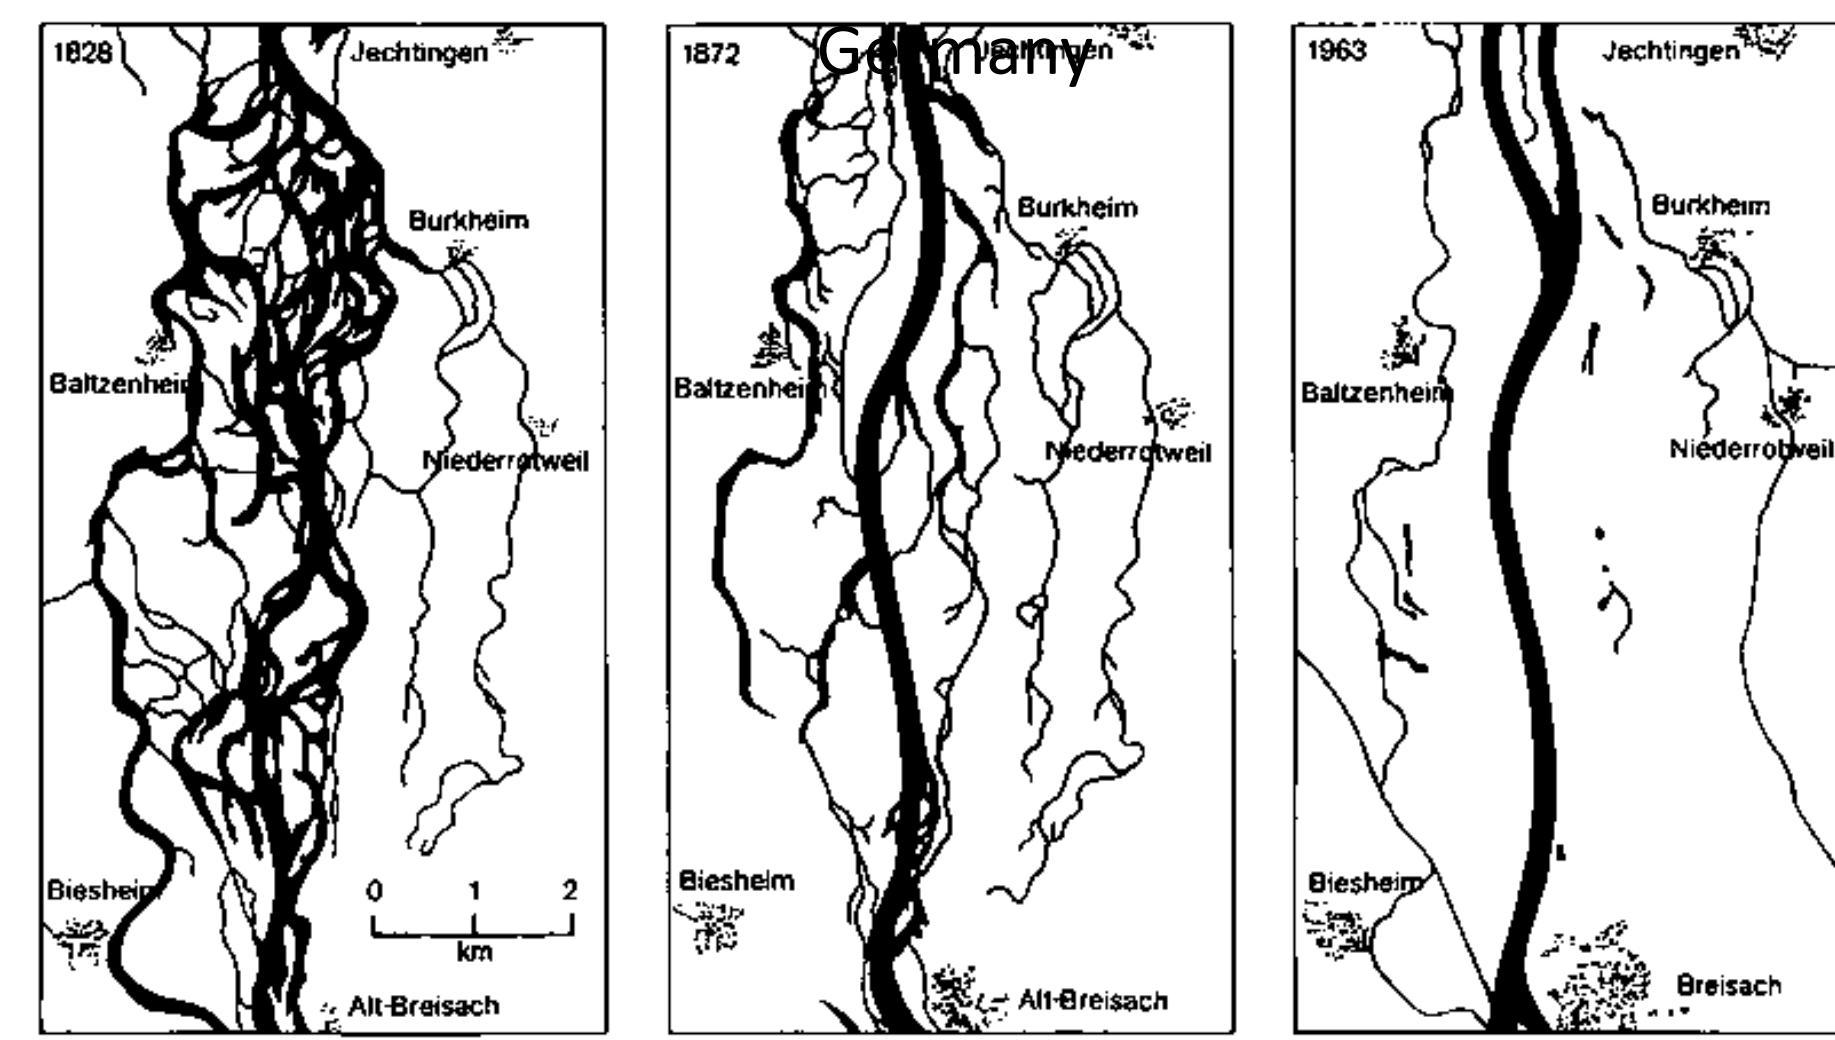
Evidence from Europe - Upper River Rhine at Breisach

Anastomosed 1828 – Prior to river training

Anabranched 1872 – after re-alignment by Johann Gottfried Tulla

Meandering 1963 – fully canalised single-thread

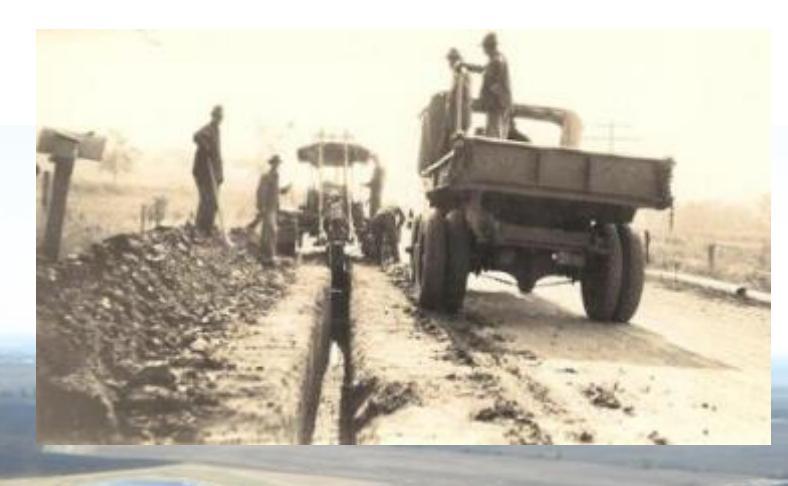
Tile drain networks: 6m acres in mid-west.

- drain upper soil moisture zones,
- diminish aquifers,
- Makes the hydrosystem flashy and less resilient.

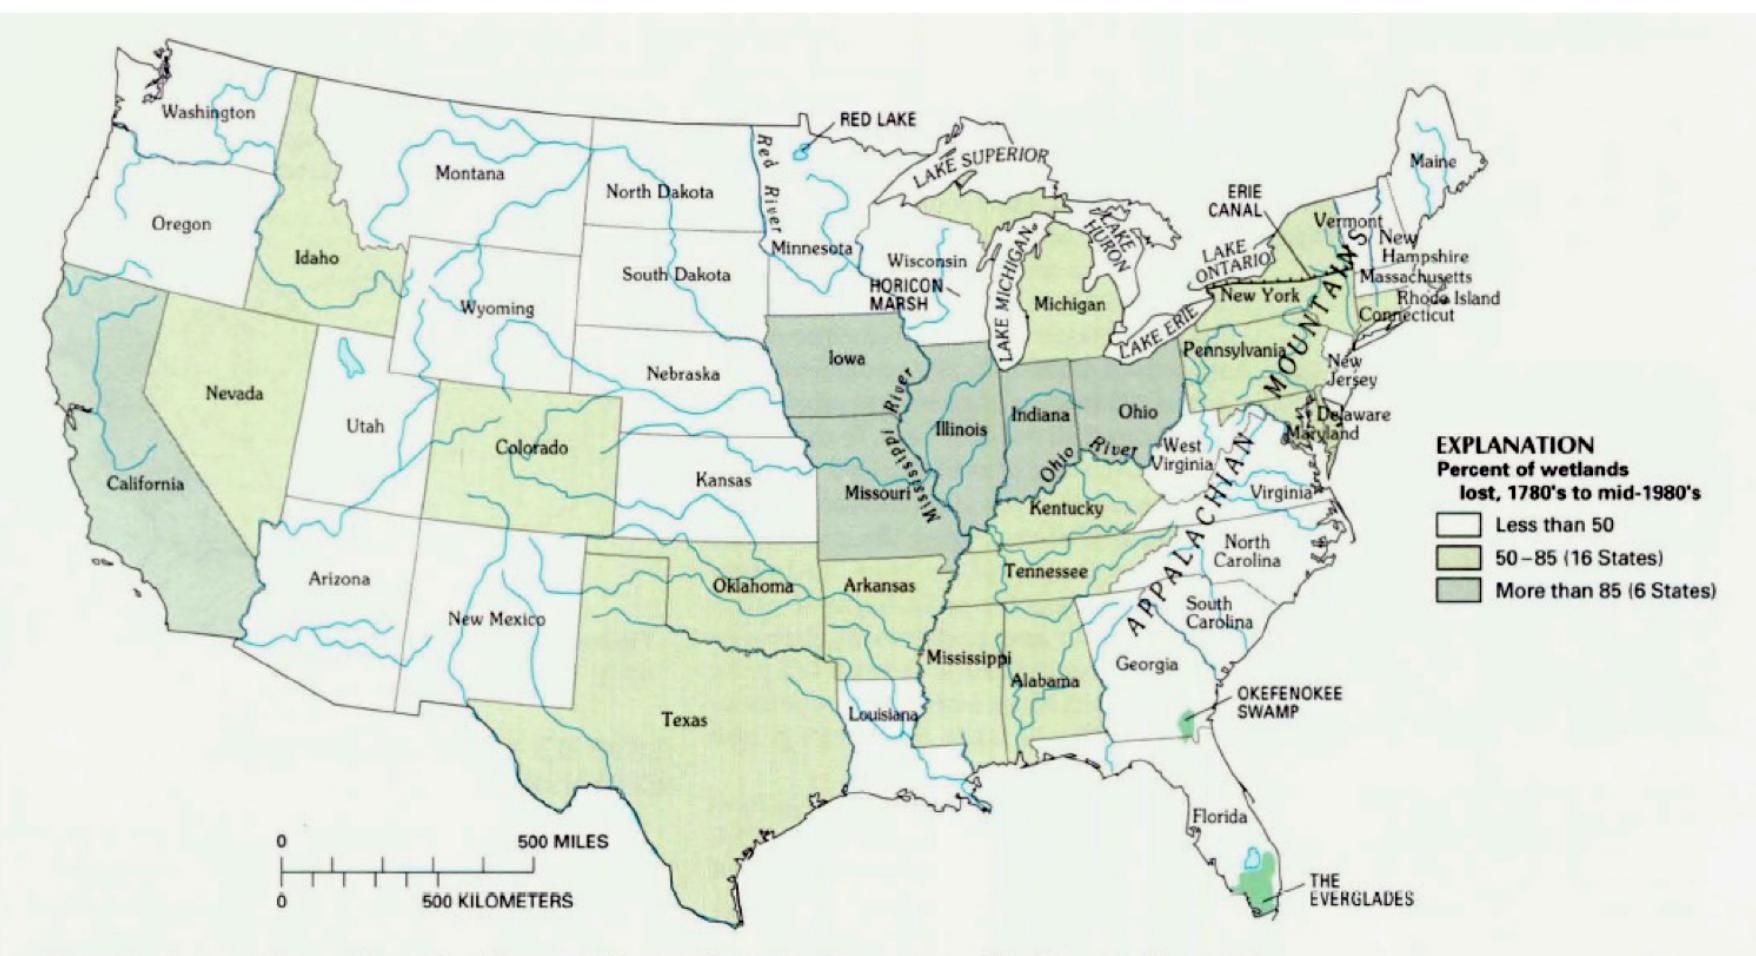
Figure 2. States with notable wetland loss, 1780's to mid-1980's. (Source: Modified from Dahl, 1990.)

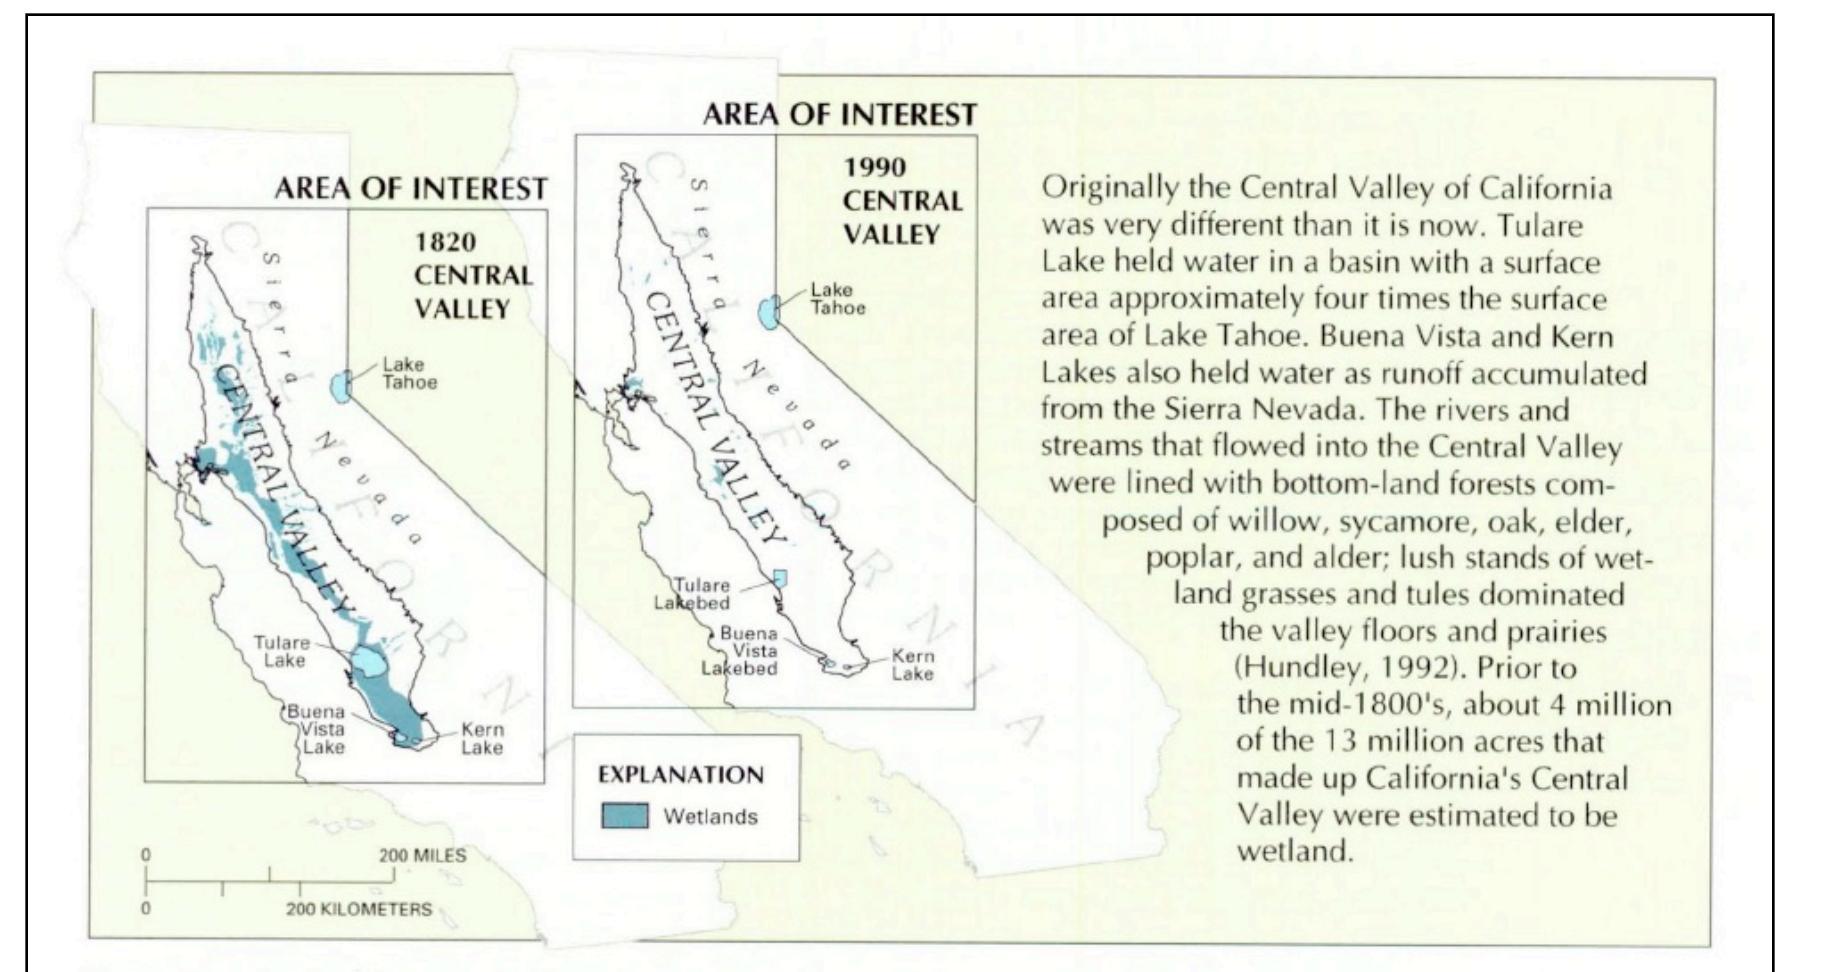
Figure 9. Wetlands of the Central Valley of California, circa 1820 (left) and 1990 (right). (Source: U.S. Fish and Wildlife Service, Status and Trends, unpub. data, 1994.)

CA, formerly 4m acres wetland, Almost 3m accessible to fish

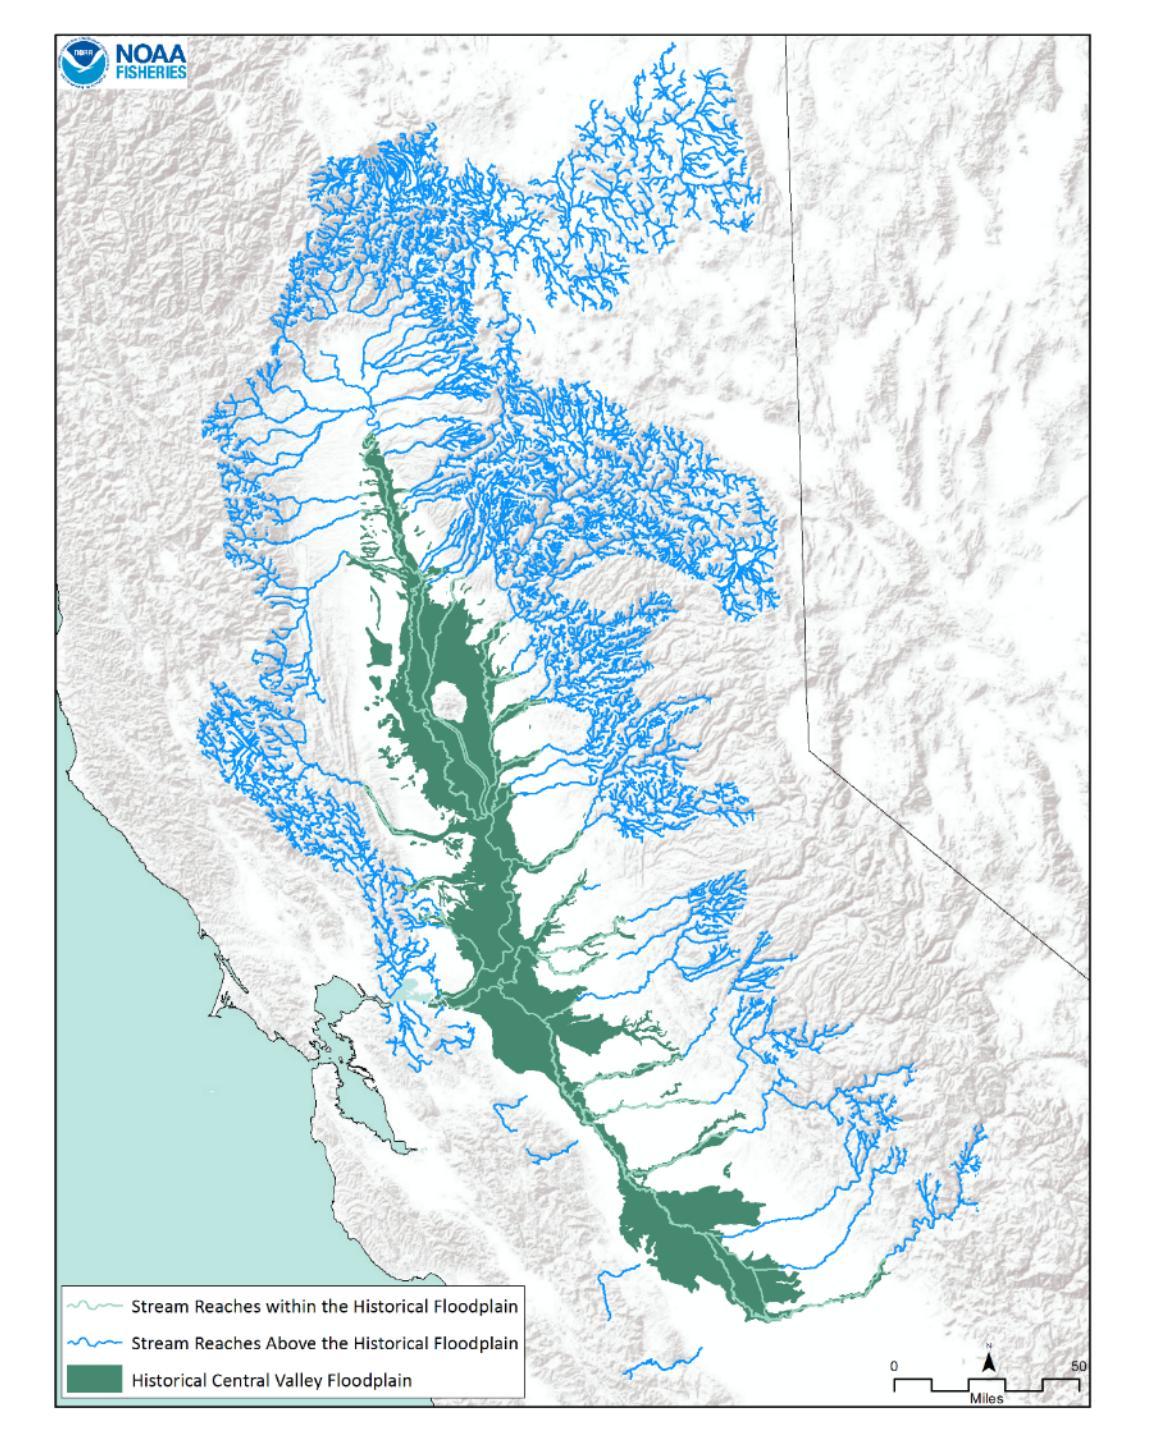
Historical Central Valley with Intact Floodplain [4450 sq mi] and Connected Streams [17200 mi]

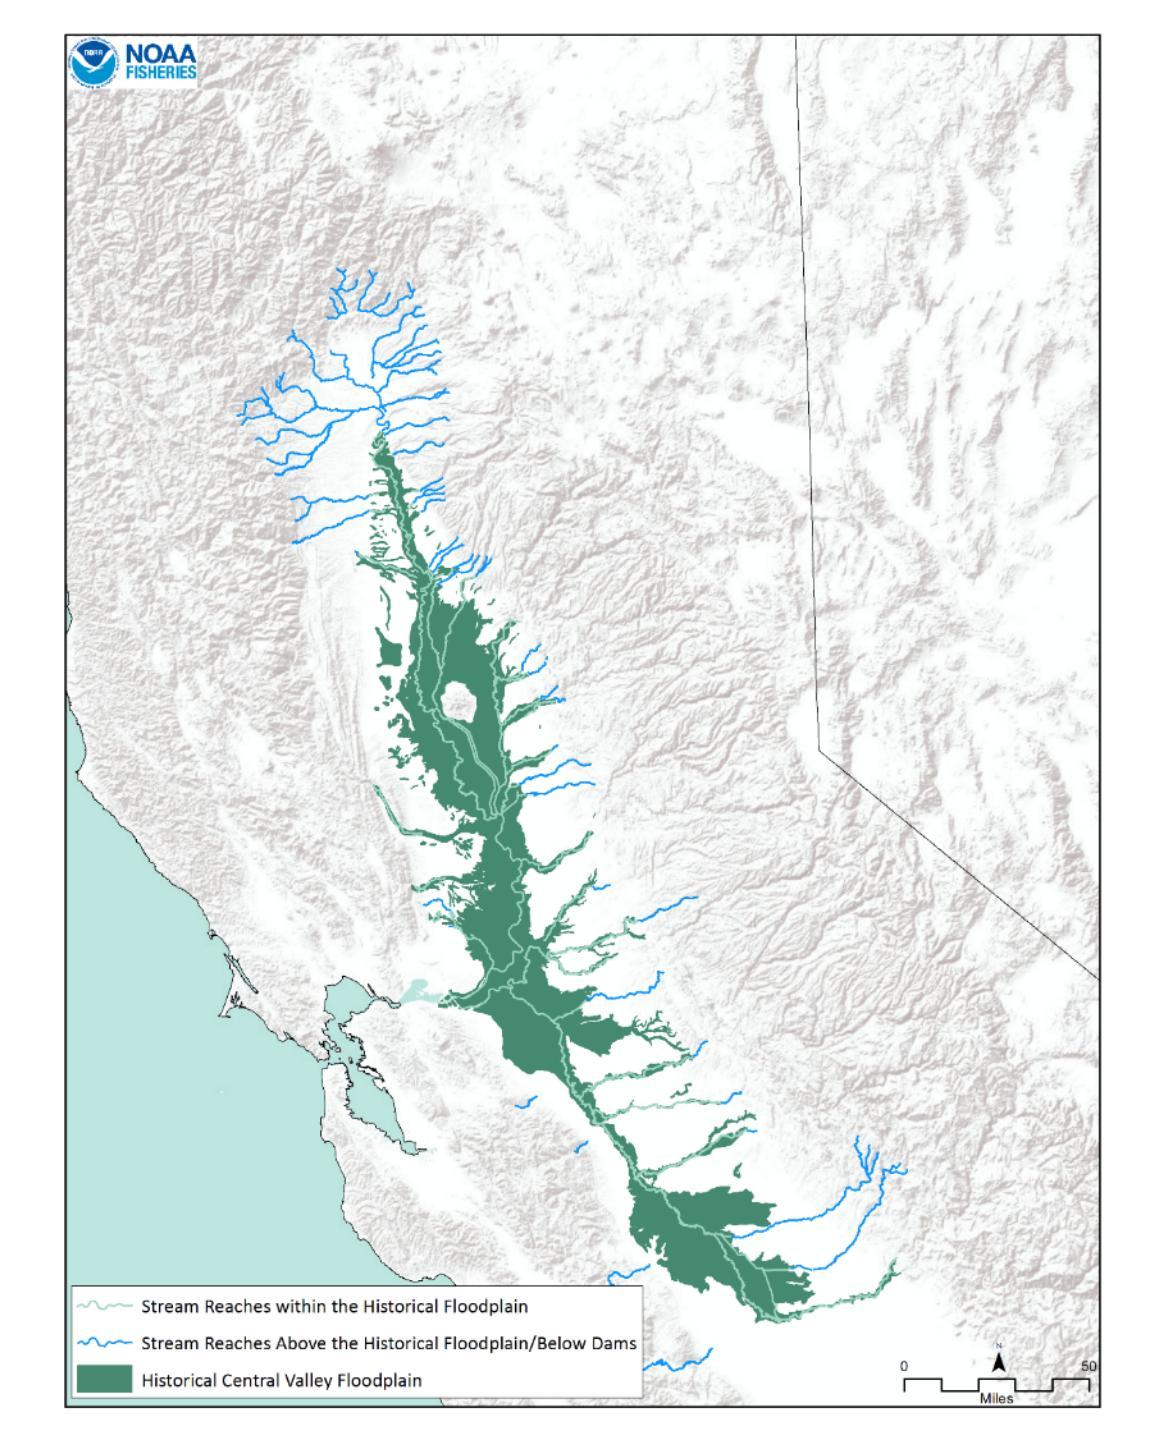
Historical Central Valley with Intact Floodplain and Stream Reaches currently accessible

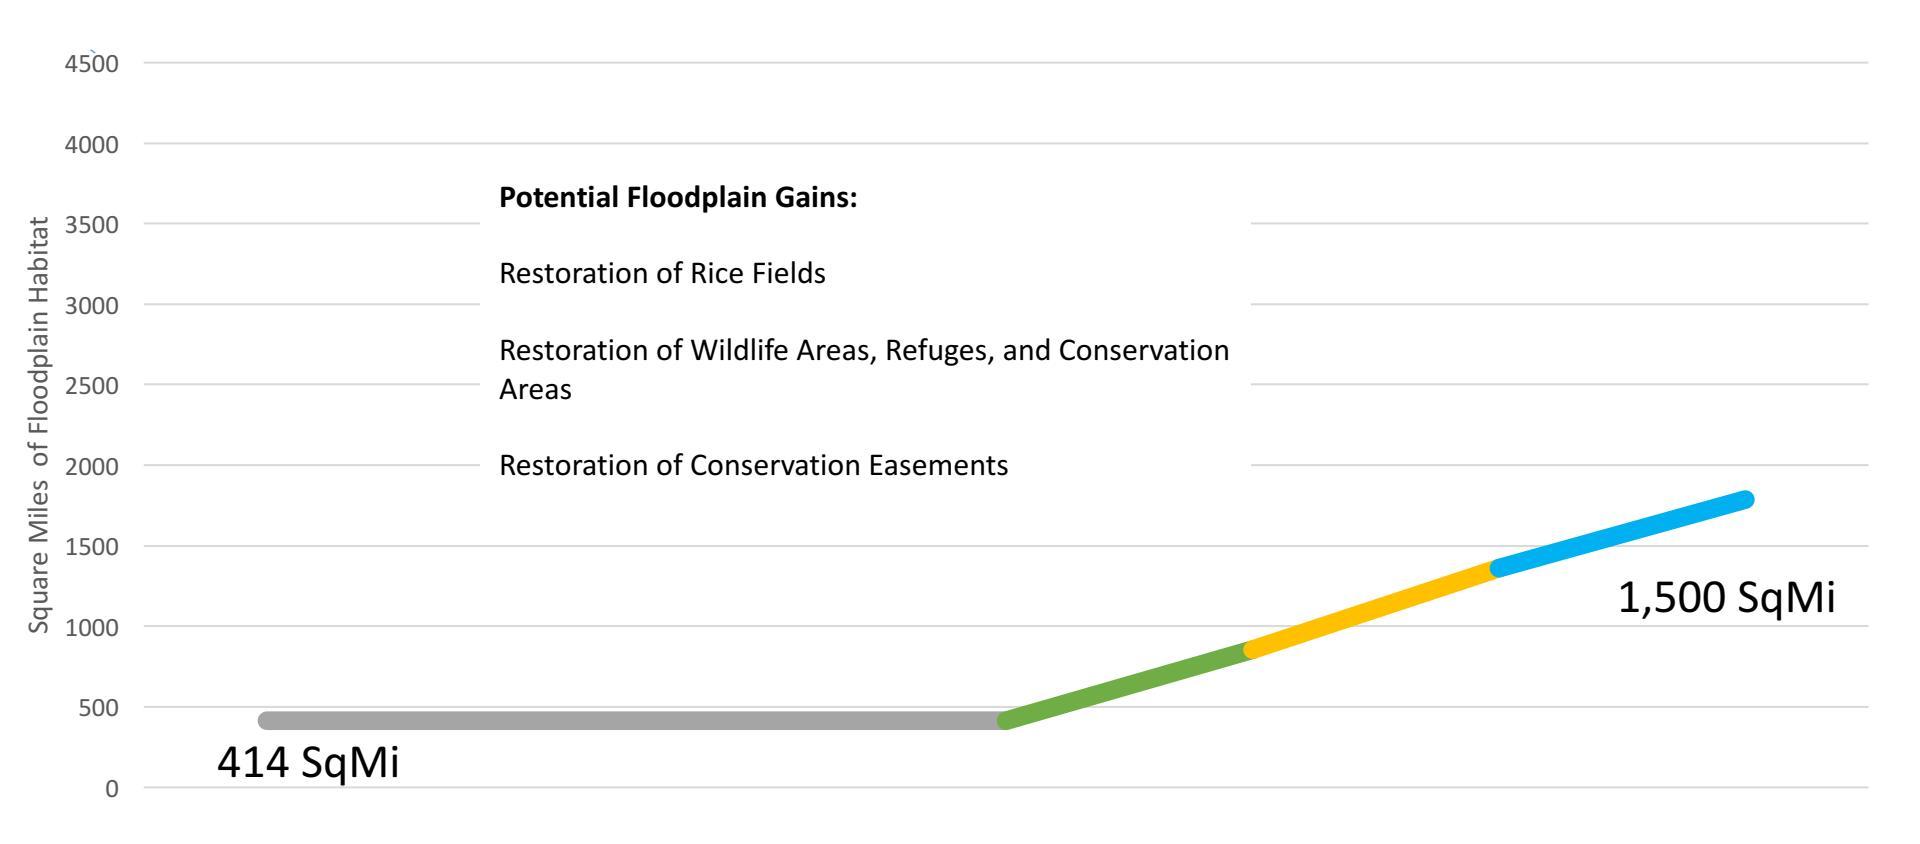
### History of Central Valley Floodplains

Square Miles				
Category	Total square miles in CV (and at least have a portion that touches the floodplain boundary*)	Connected to River (a portion of entity within 1 kilometer of watercourse)	Disconnected from River (no portion of entity within 1 kilometer of watercourse)		
Rice Fields	441	396	45		
Consevation Easements	425	381	44		
Existing Wildlife Ares	410	406	4		
(NWR, WA, Preserve, Riparian Habitat)					
Existing Floodplain Habitat	295	295	295		
Perennial Water	120				
Total Floodplain Habitat counting Existing and Potential	1571	1478	388

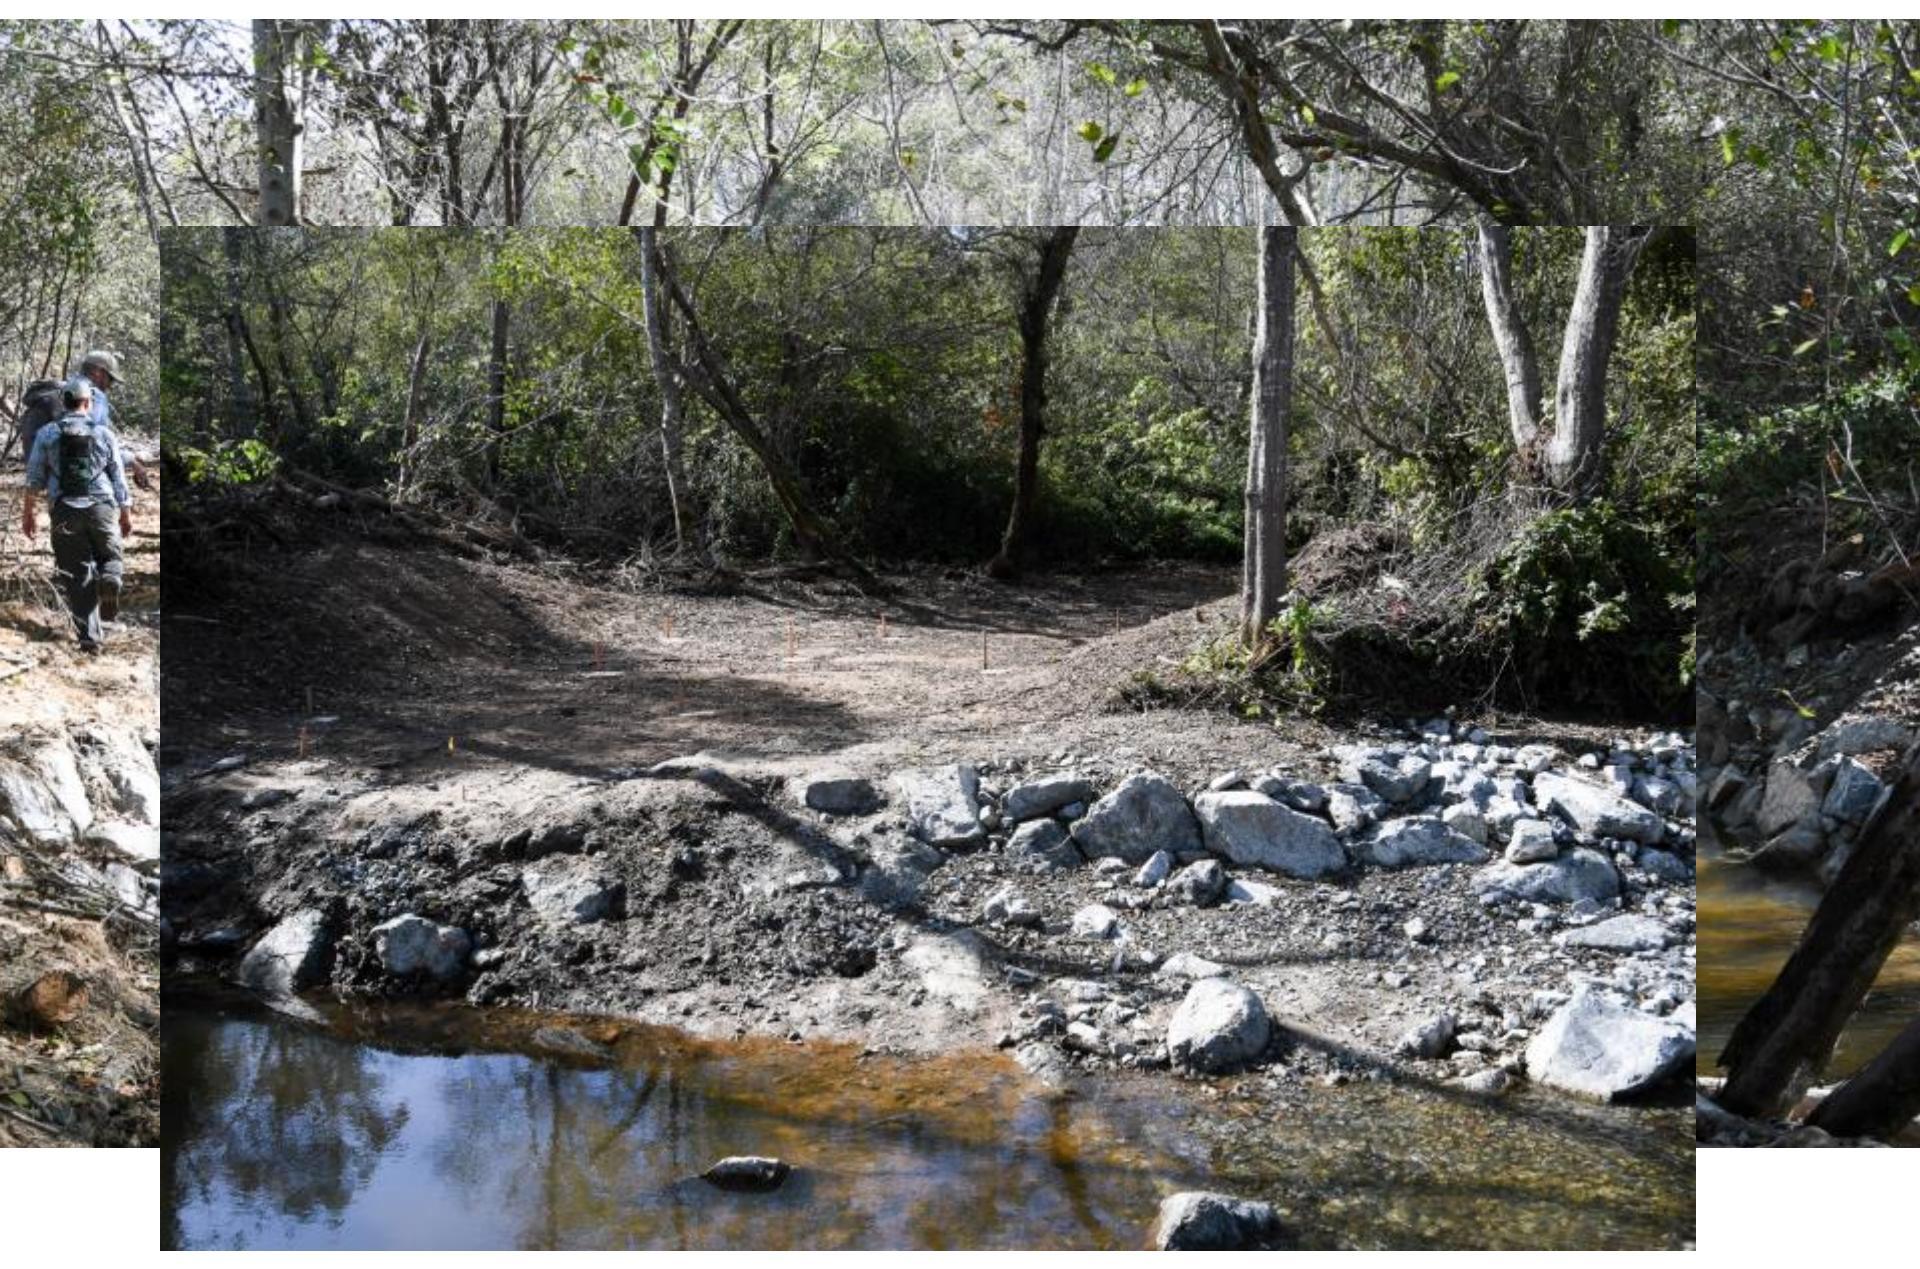
Butano Creek – plug channel and lower levee

- Plug the channels that drain the water table
  - Immediate results
- Re-establish alluvial fan deposition and recharge zones
- Levees: move, breach, etc.

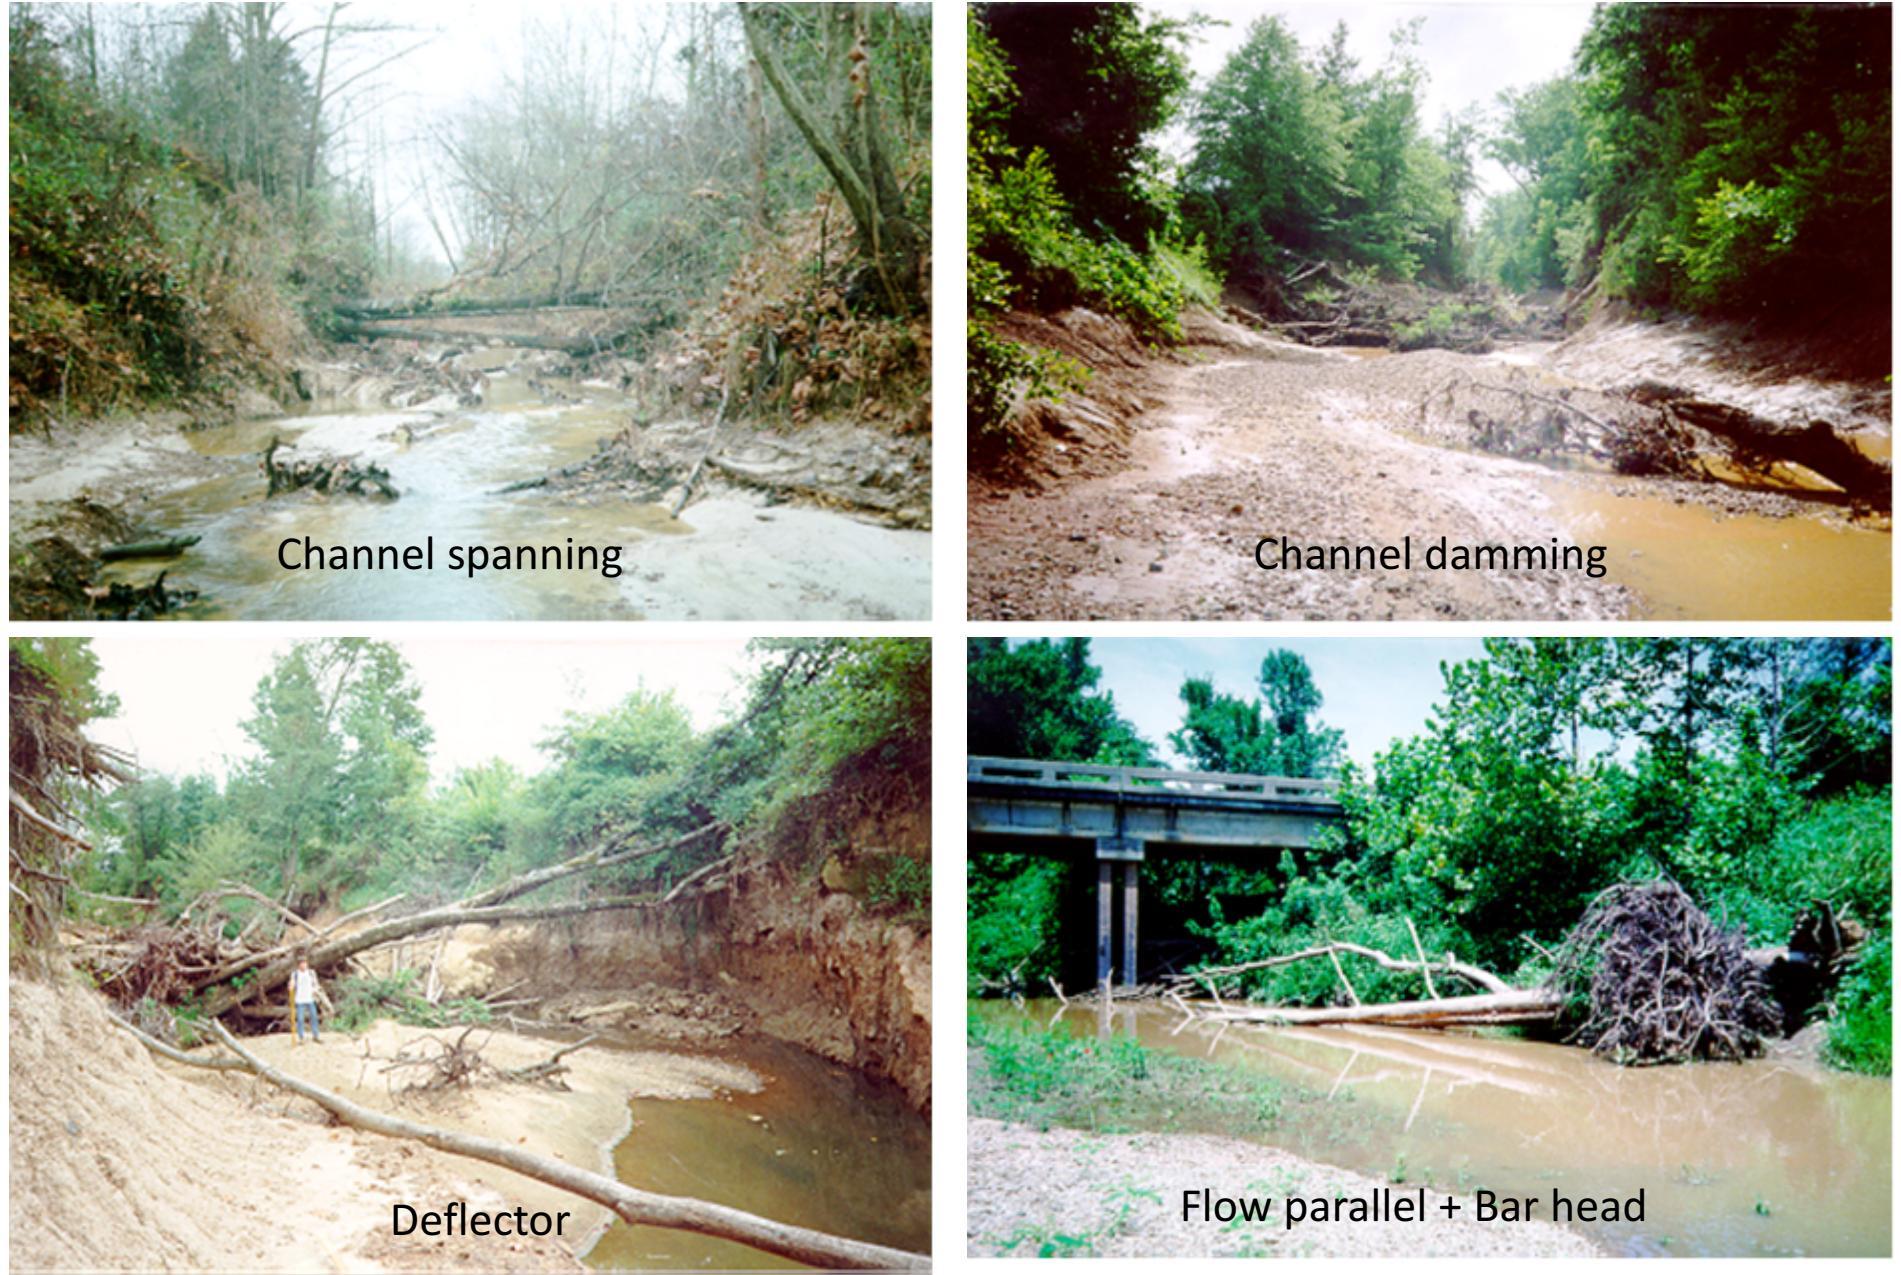
### Add wood or restore wood recruitment in incised channels

Wallerstein, N.P. and Thorne, C.R., 2004. Influence of large woody debris on morphological evolution of incised, sand-bed channels. *Geomorphology*, 57(1), pp.53-73.
